4. TITLE (and Subtitle) Stodge Meadow Pond Dam NATIONAL PROGRAM FOR INSPECTION OF NON-FEDERAL DAMS		5. TYPE OF REPORT & PERIOD COVERED INSPECTION REPORT

STODGE MEADOW POND DAM

MA 00009

FEBRUARY 1979

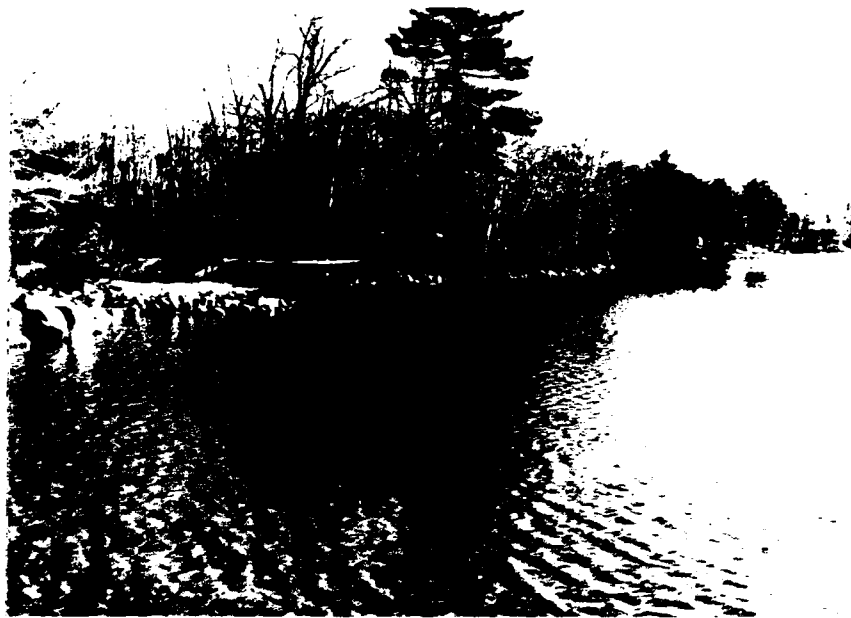
1. Overview of Stodge Meadow Pond Dam showing upstream side

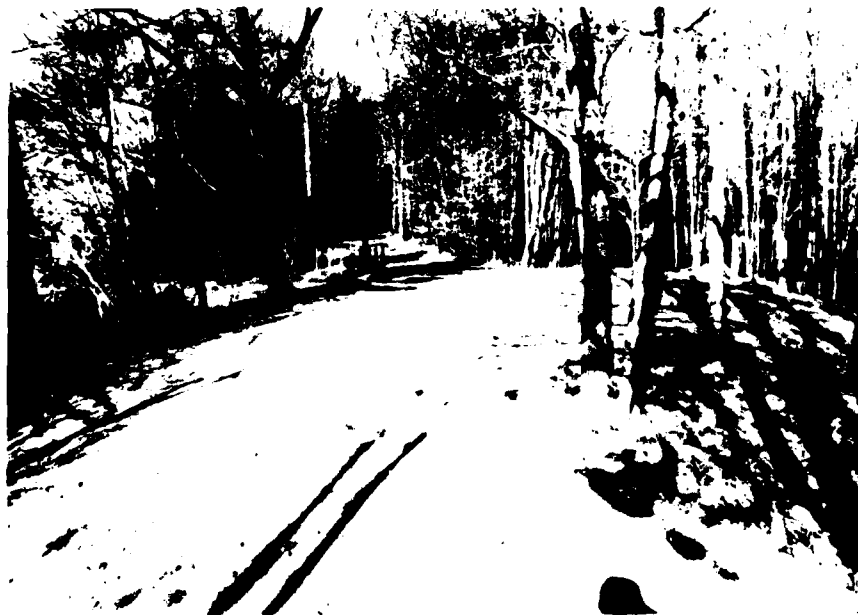
7. Top of embankment near conduit spillway and left abutment
